TundrCore - CASE STUDY

Hidden Moisture Failure in Cold-Climate Sanitary Infrastructure

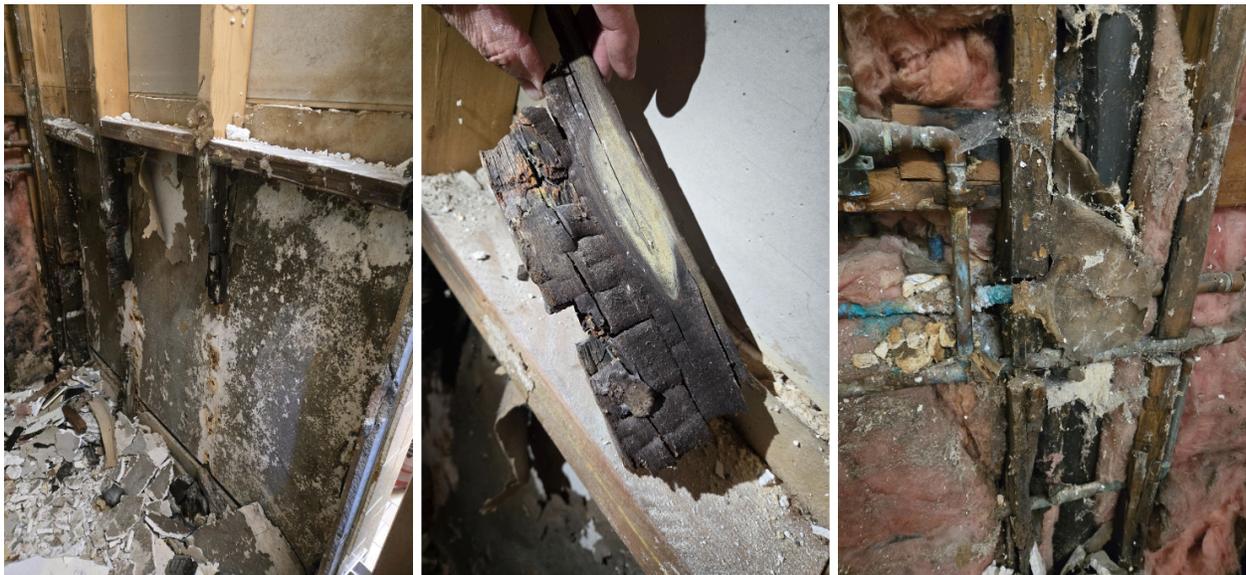
Load-bearing framing members exhibited extensive rot and loss of material integrity due to prolonged moisture exposure. In some cases, wood components had degraded to the point of crumbling under hand pressure, indicating long-term compromise rather than recent damage.

Mold growth and moisture-saturated insulation were present behind finished surfaces. Fibrous insulation had absorbed and retained moisture, effectively acting as a reservoir that prevented drying and accelerated biological activity.

The shower assemblies lacked a continuous waterproofing plane. Water migration occurred behind finished surfaces, with no controlled drainage path. Moisture was able to penetrate structural cavities and remain trapped.

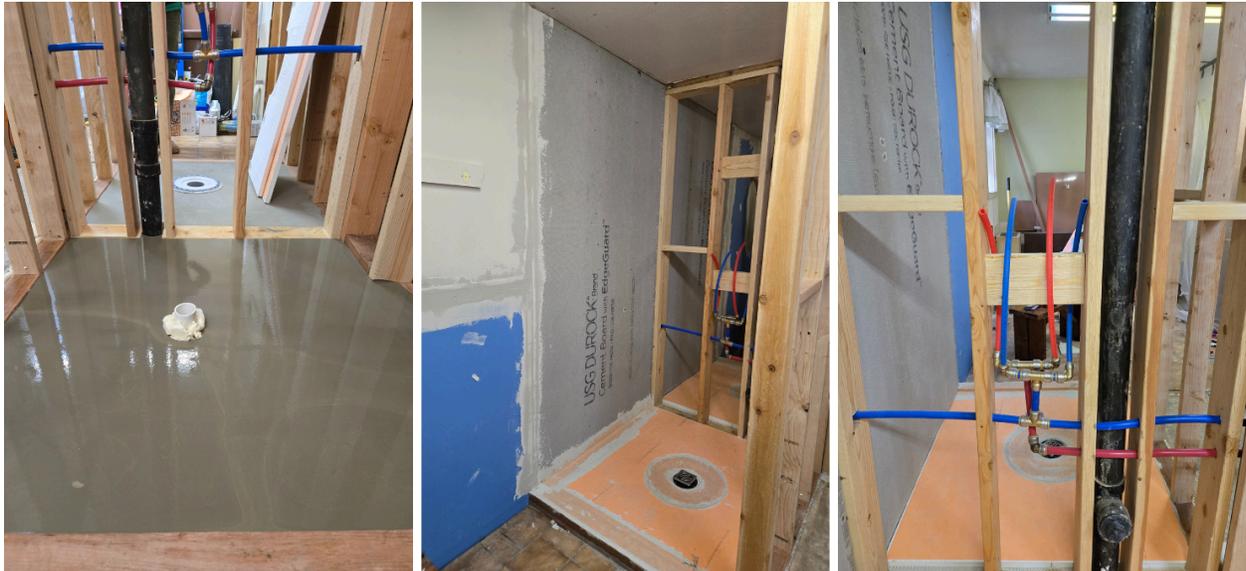
- Restored structural integrity
- Controlled moisture pathways
- Reduced biological risk
- Improved serviceability and inspection access
- Extended service life
- Significantly reduced likelihood of hidden degradation

The facility transitioned from a failure-masked system to a **failure-tolerant, inspectable assembly**.
