CASE STUDY: Adaptive Vault Design in Clay Soil – Preventing Systemic Collapse at High Altitude

Project Overview

Client: Private RV Park, Southern Rockies

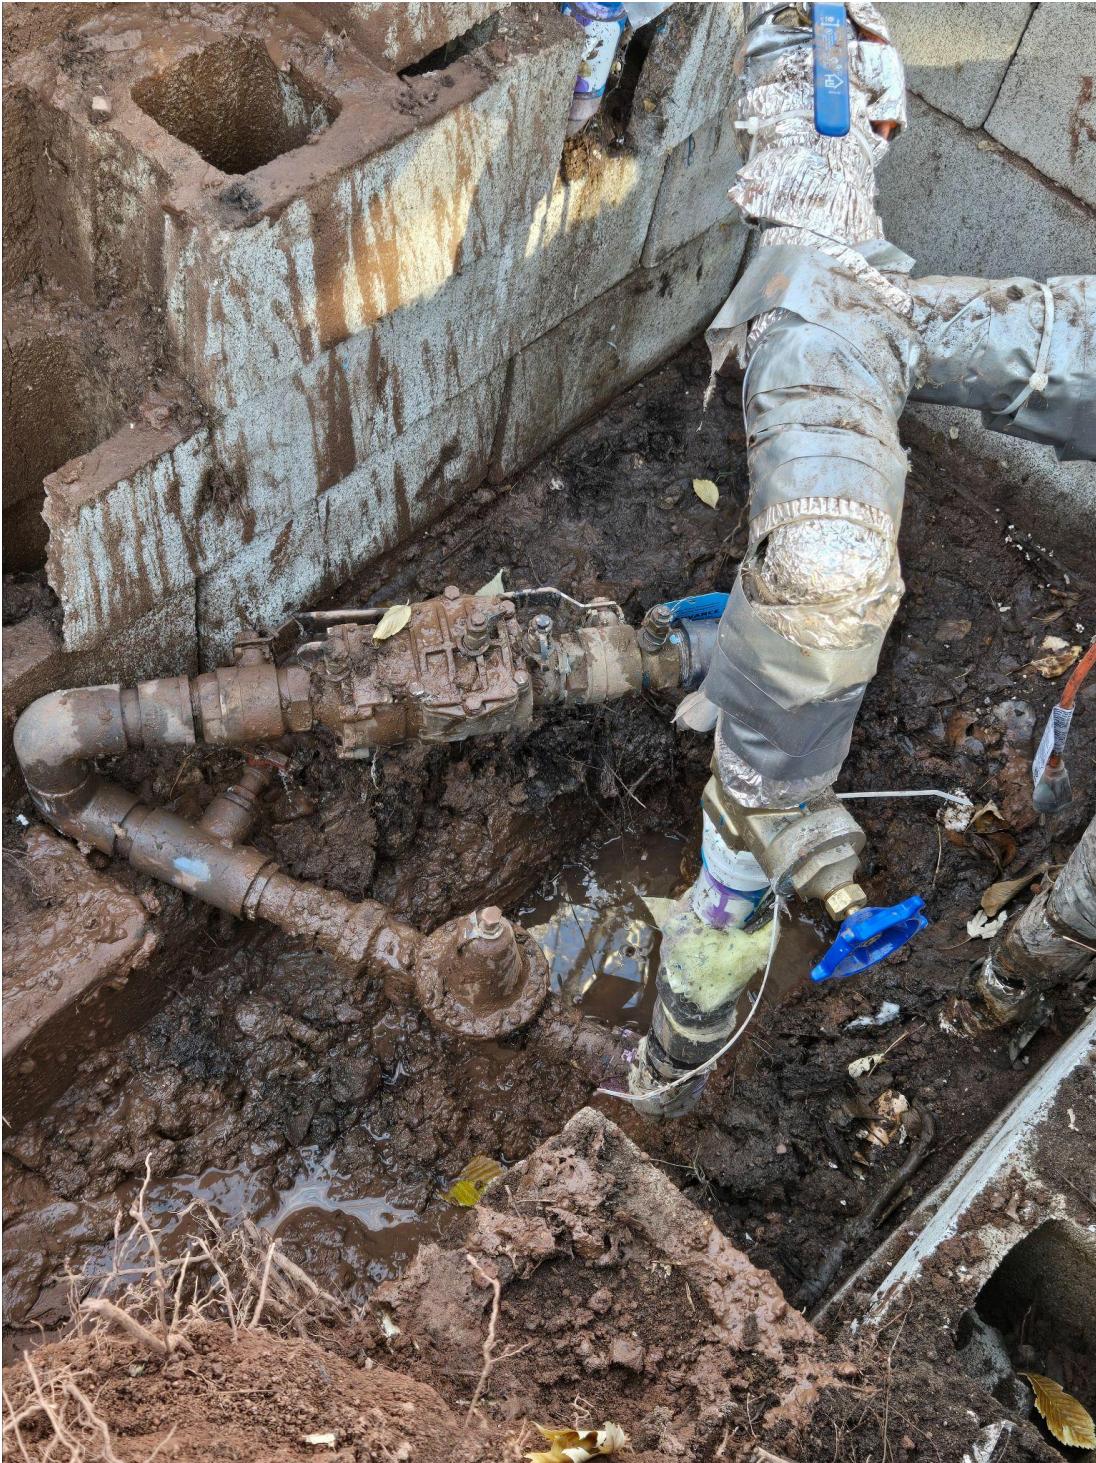
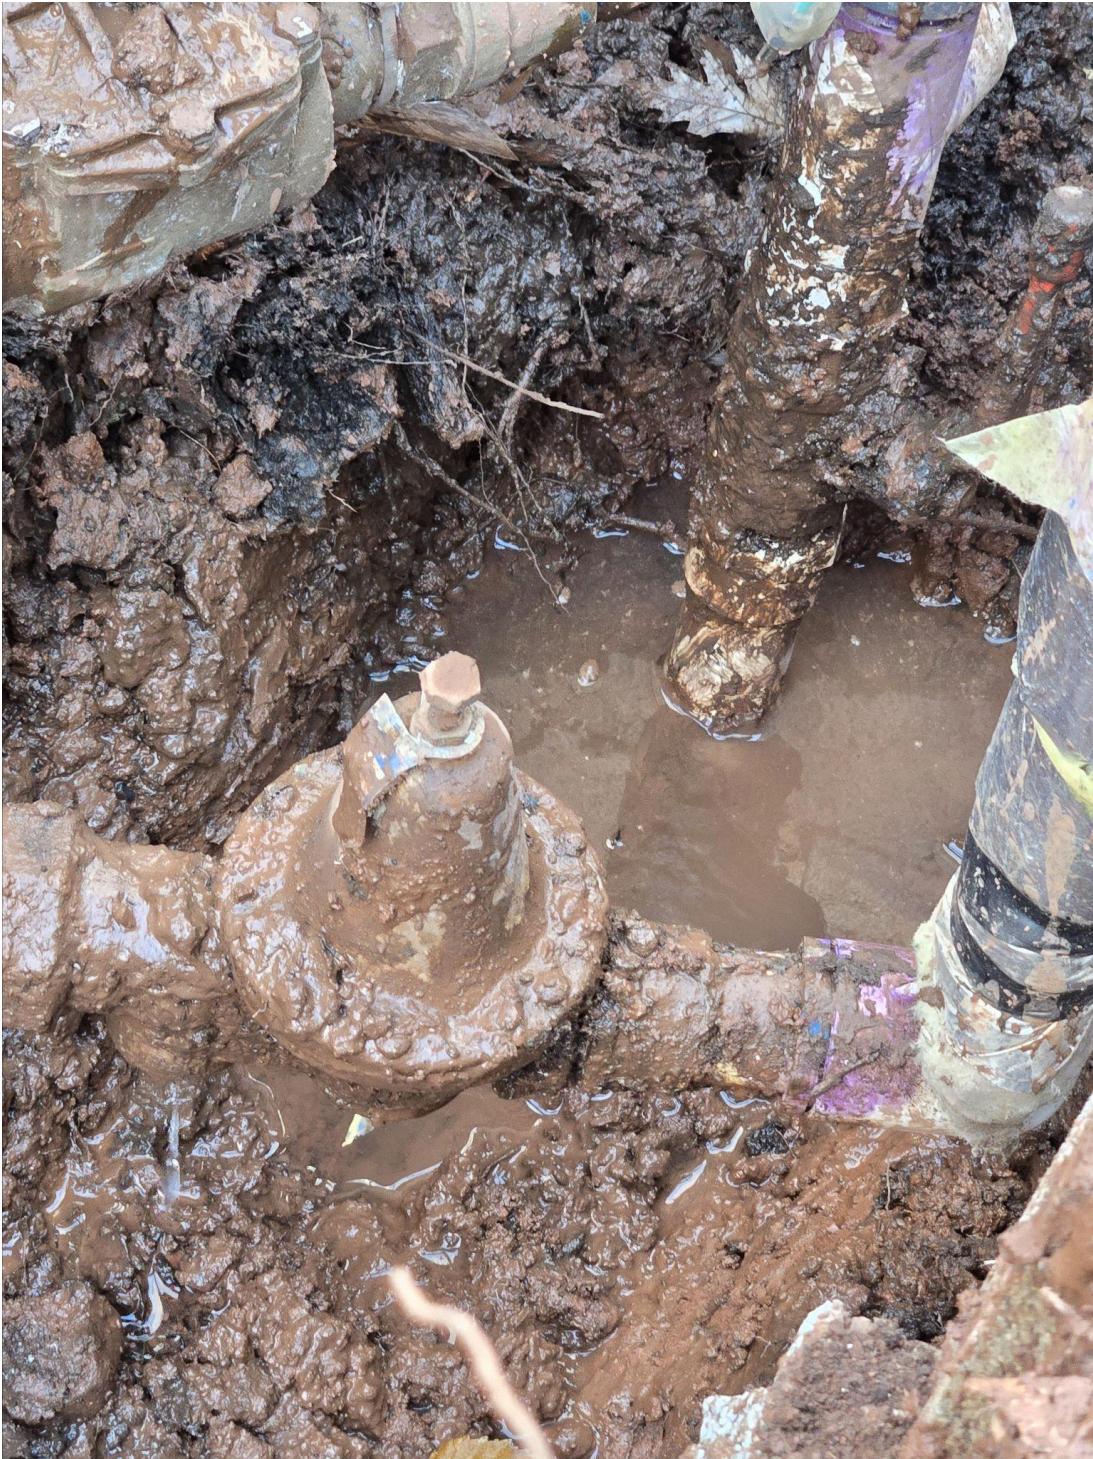
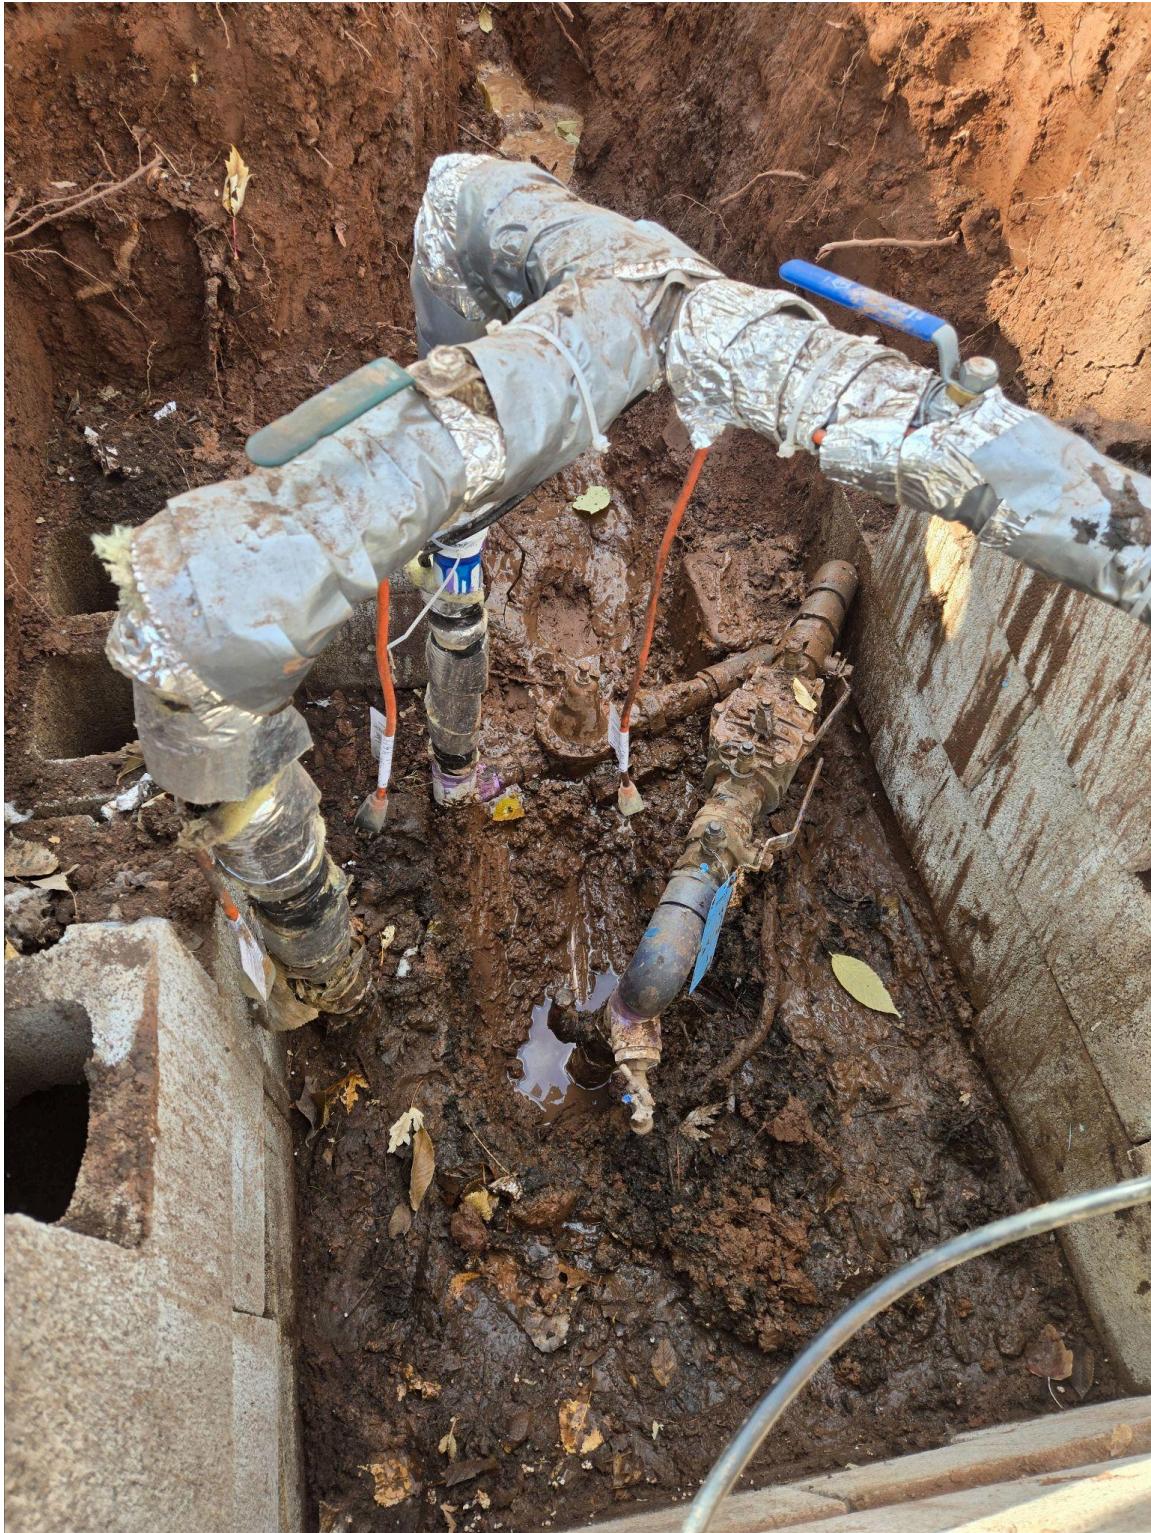
The existing order of infrastructure hierarchy made little sense, with a primary system isolation gate-valve downstream of both PVR and BFP, and a 3rd mains waterline entirely unregulated and unprotected by the PVR and BFP, and with no shutoff outside of county support, found to be feeding park infrastructure.

There was a crack in the bottom of the PVR, contributing to significant water accumulation in the clay base vault, and pipework was sitting mere inches beneath the surface, well within the frost line, protected from the freezing alpine winters by nothing more than foil wrap, heat tapes and a thin piece of deteriorating plywood.

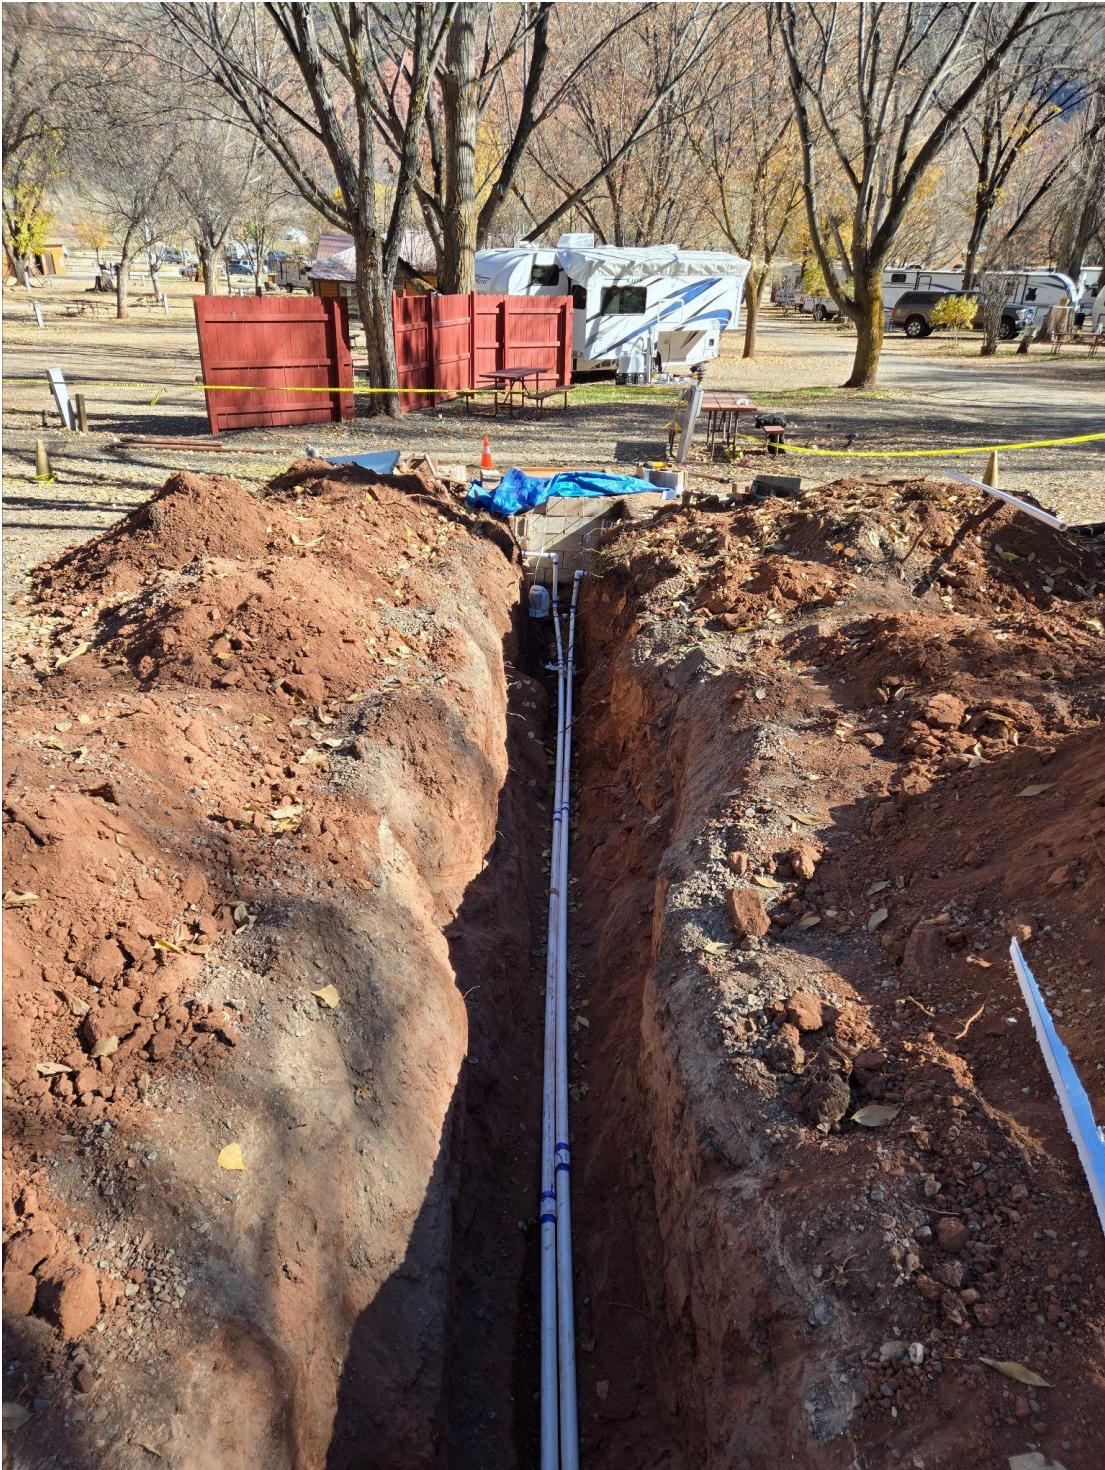
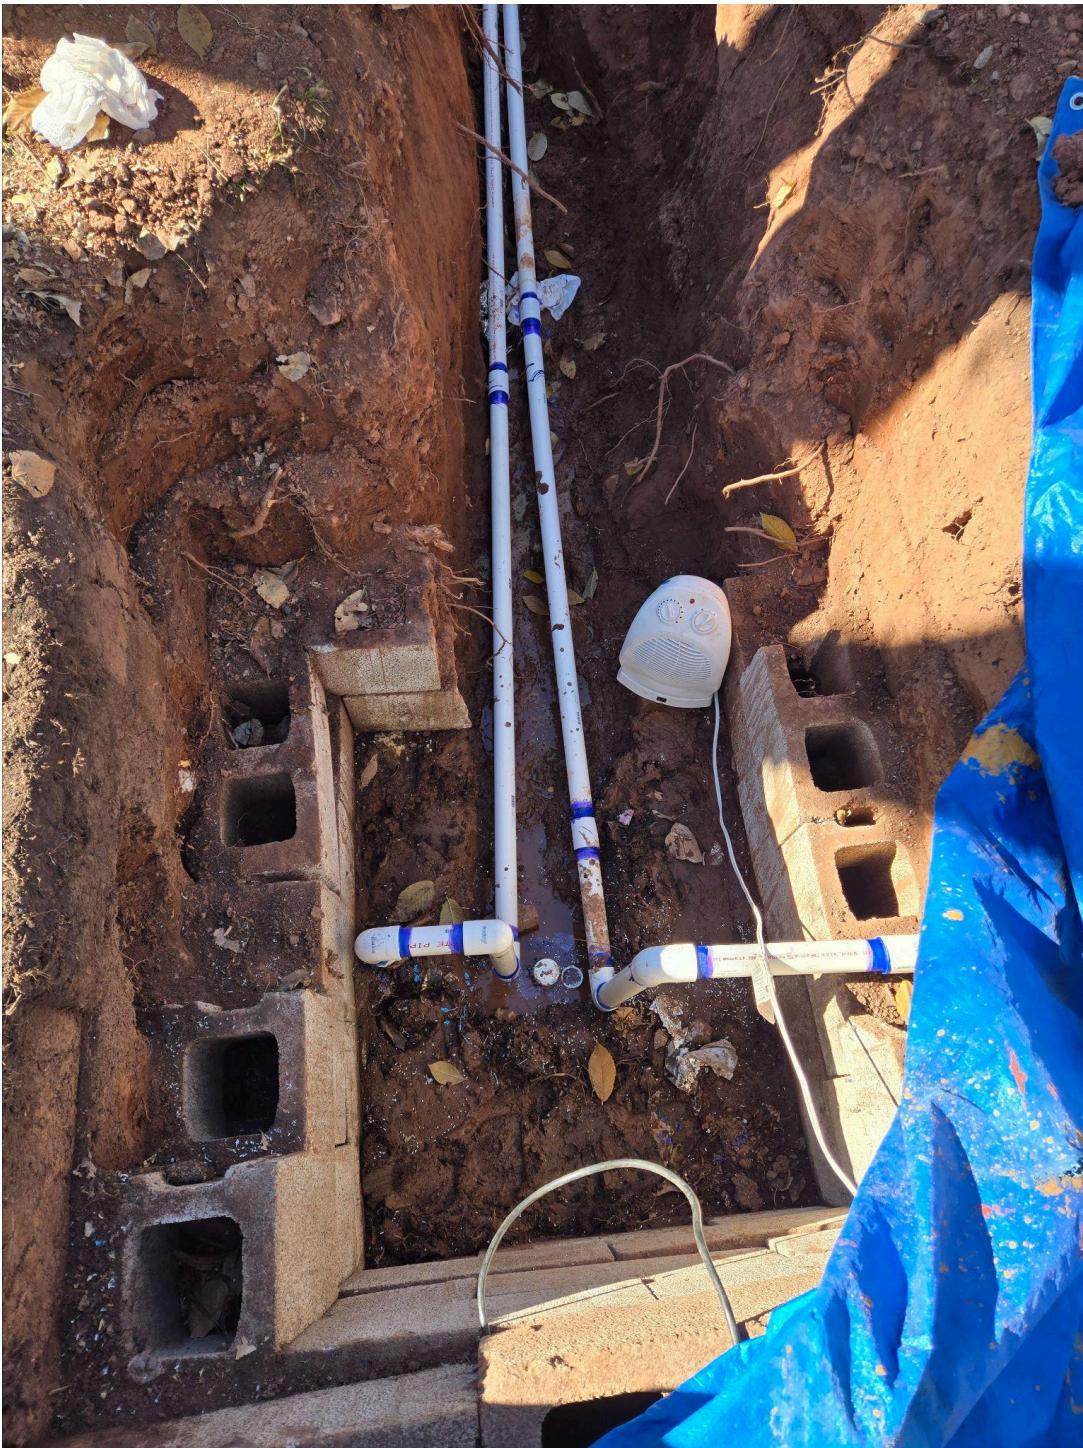
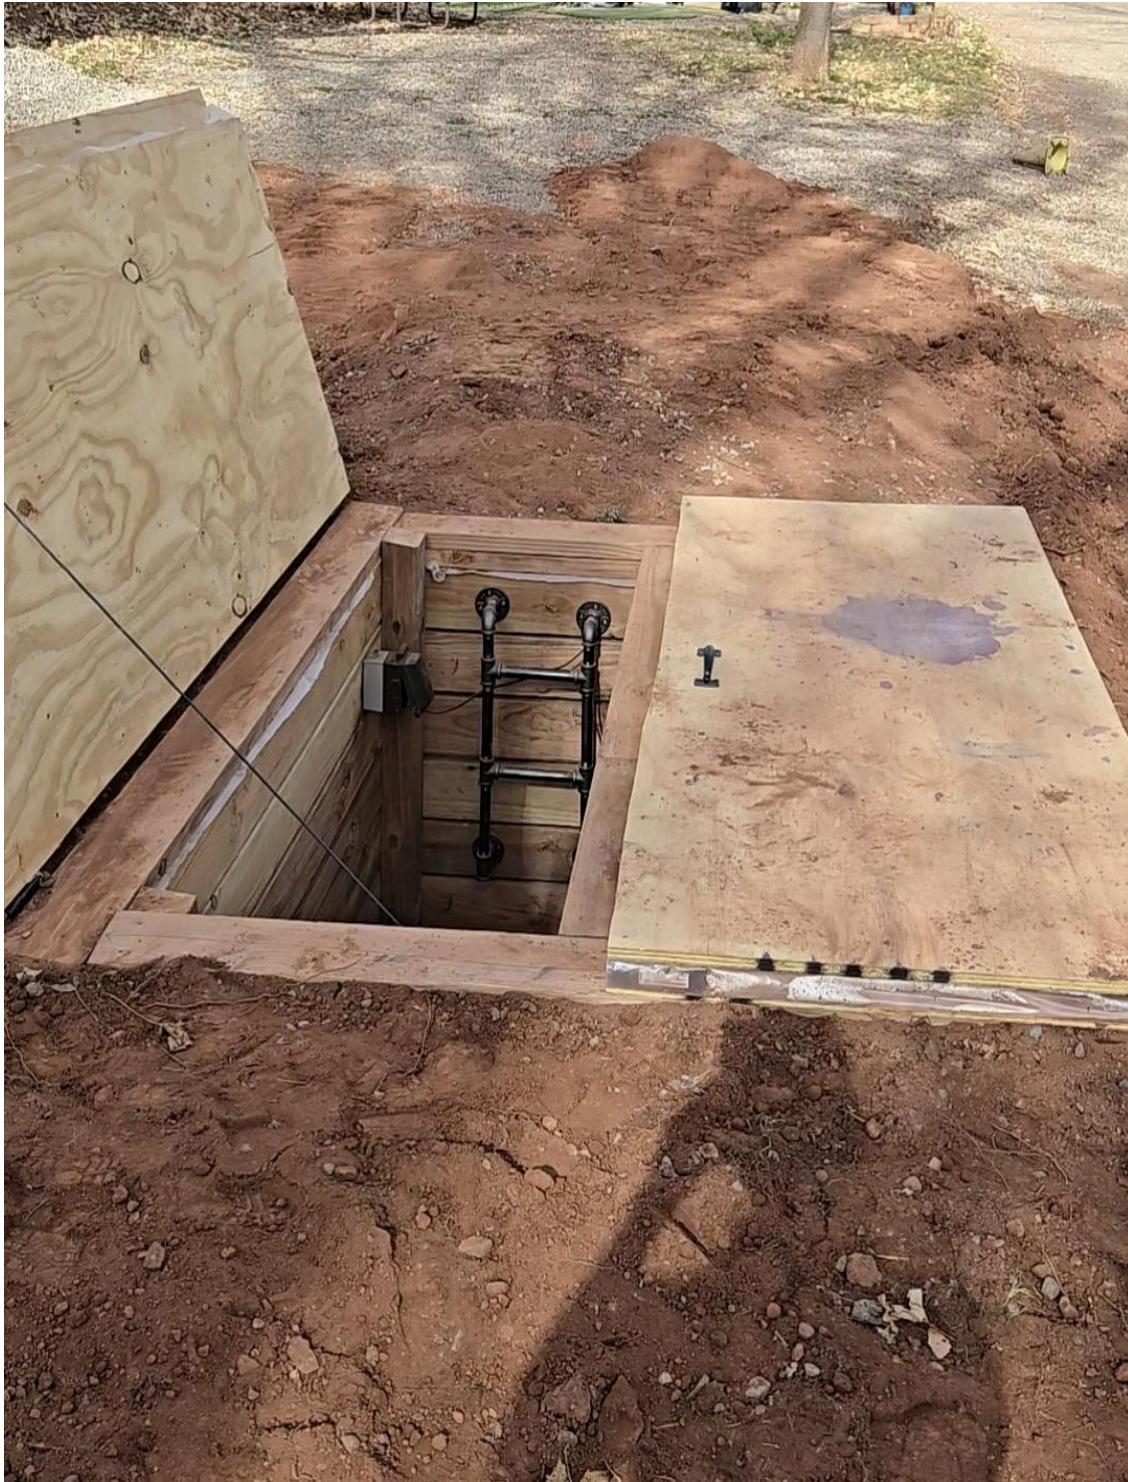
Our solution: a composite vault built from pressure-treated 2x6s – flexible, breathable, and serviceable in real time.

No direct earth contact: wrapped in R10 foam board and plastic, backfilled with $\frac{3}{4}$ stone for drainage and stability.

Every surface treated with Penashield and Tung oil for a living, breathing barrier that only strengthens with age.

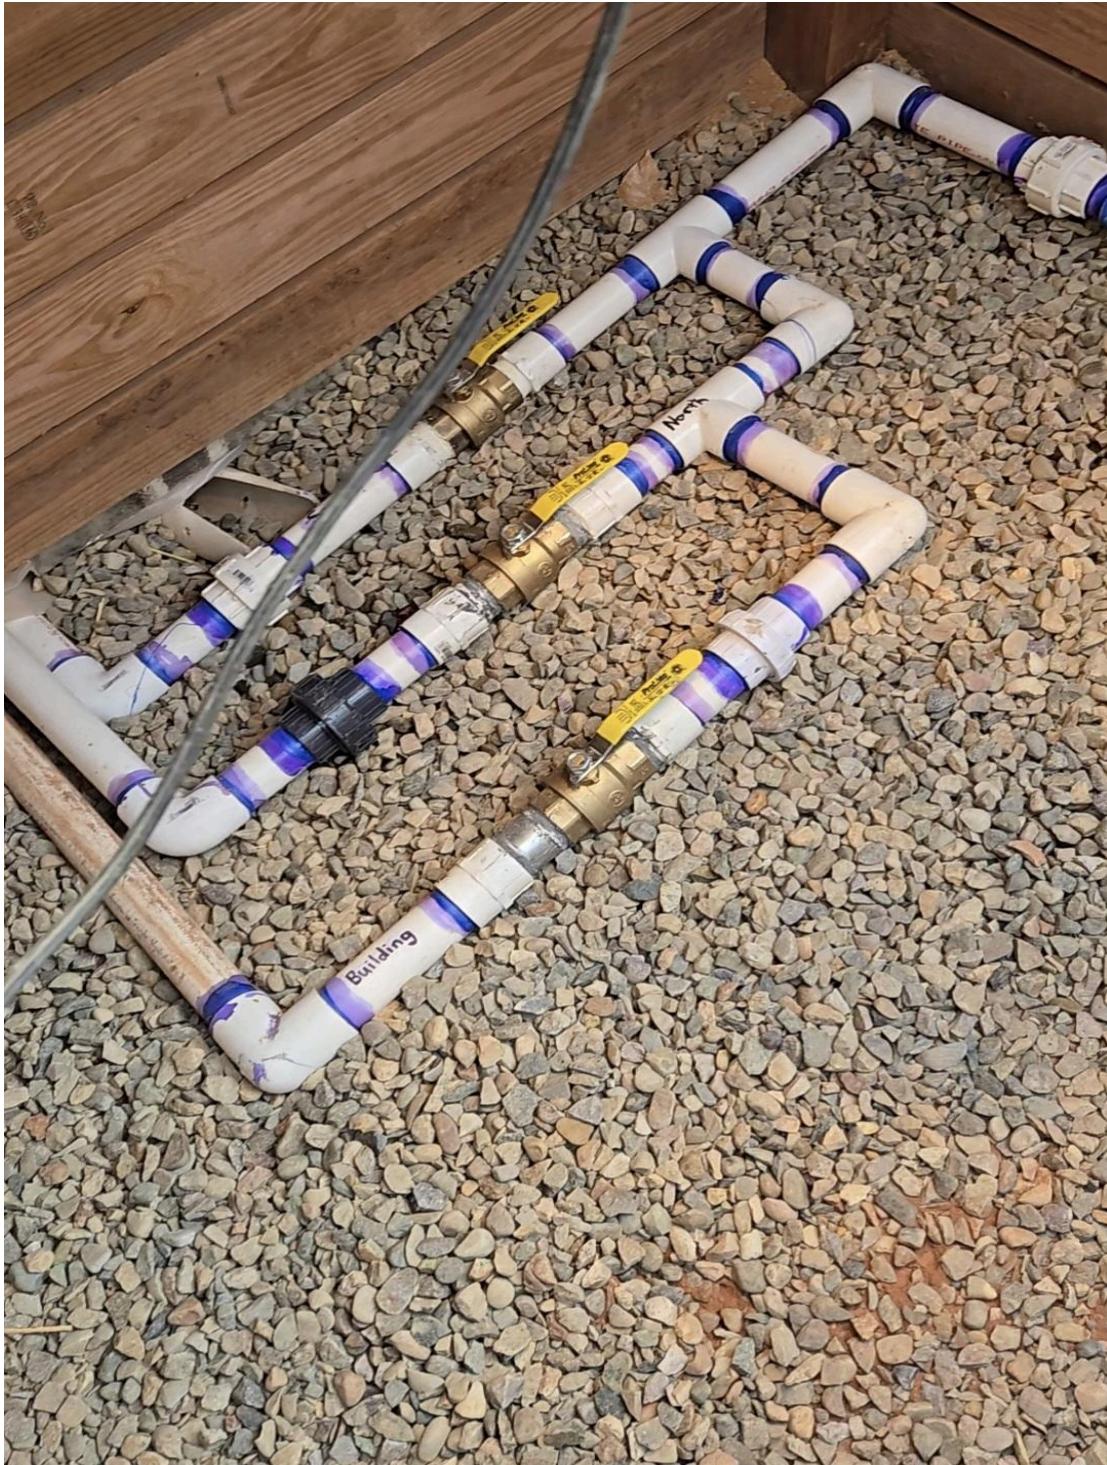
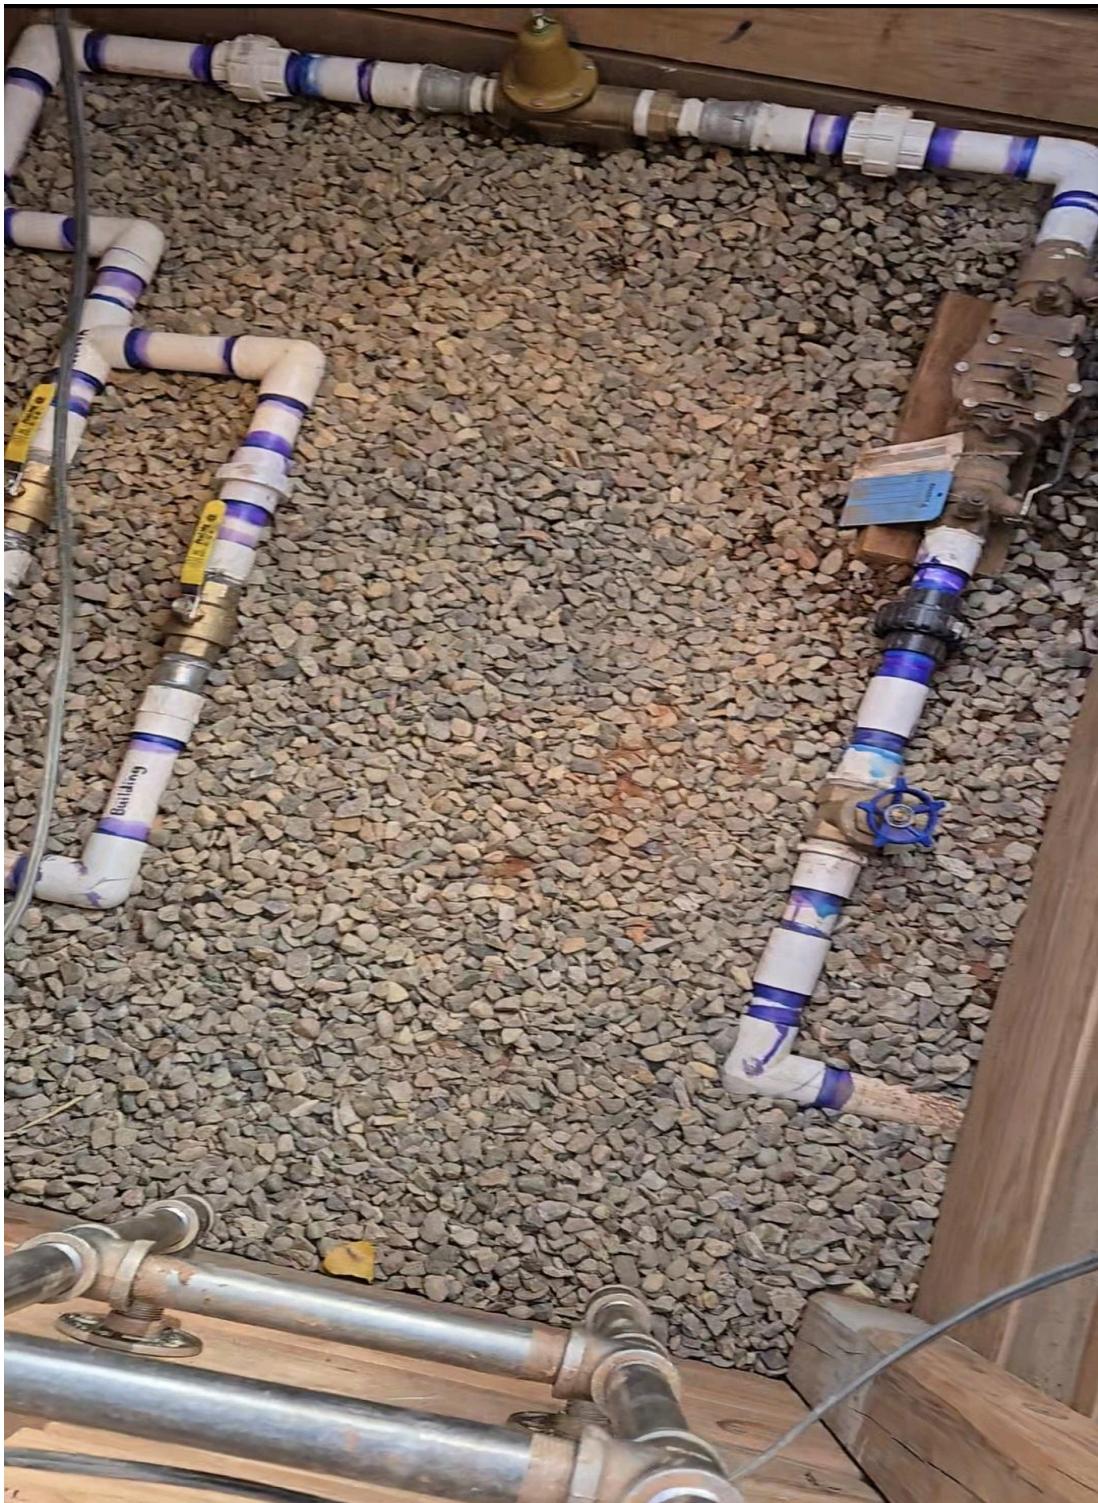
The lids are composed of dual-layer marine ply, R10 insulated core, plastic inner membrane, with a polyurethane outer finish.

The vault has been wired for 20-amp service with a hard mounted heat lamp for frost protection.

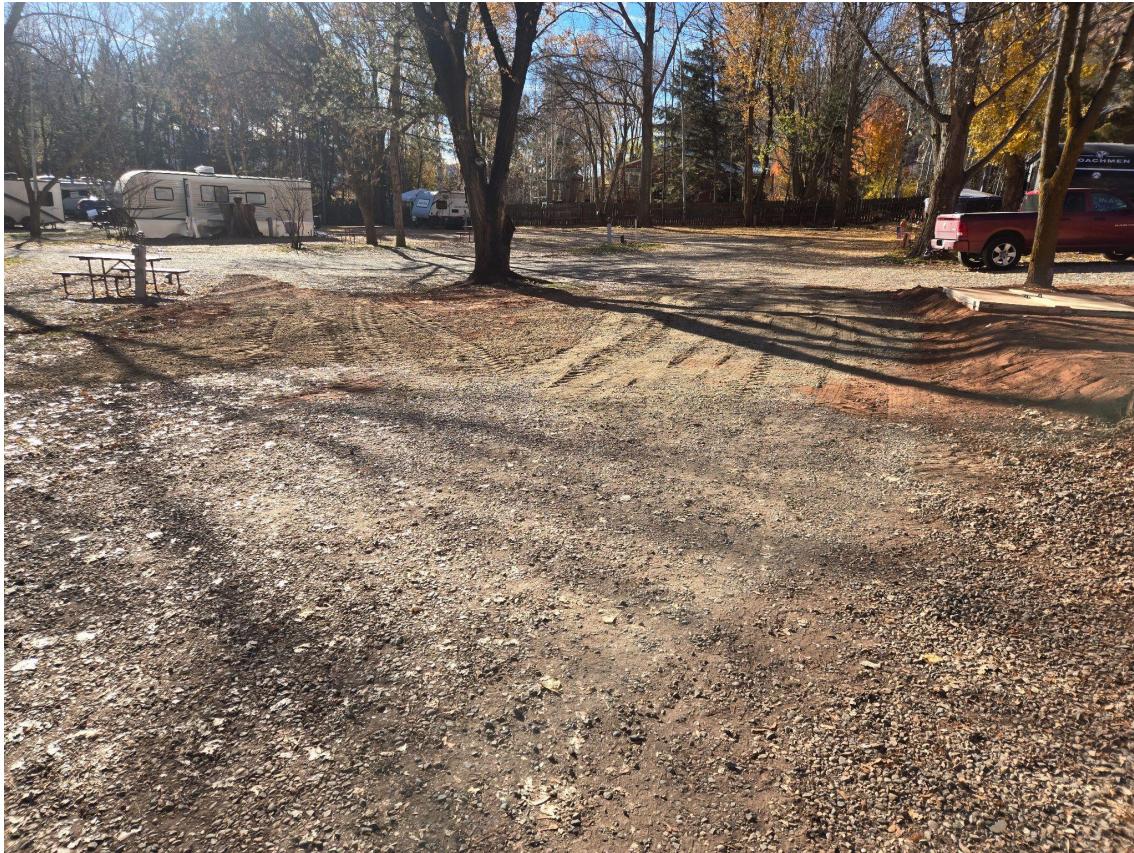
Full site rehabilitation post project
